# **TROUBLESHOOTING AND OPTIMIZING REFINING VACUUM TOWERS**

*Prepared for Presentation  
at the  
Kister Distillation Symposium 2019  
Topical Conference  
at the  
2019 Spring Meeting and 15<sup>th</sup> Global Congress on Process Safety  
of the  
American Institute of Chemical Engineers  
New Orleans, Louisiana  
March 31 – April 4, 2019*

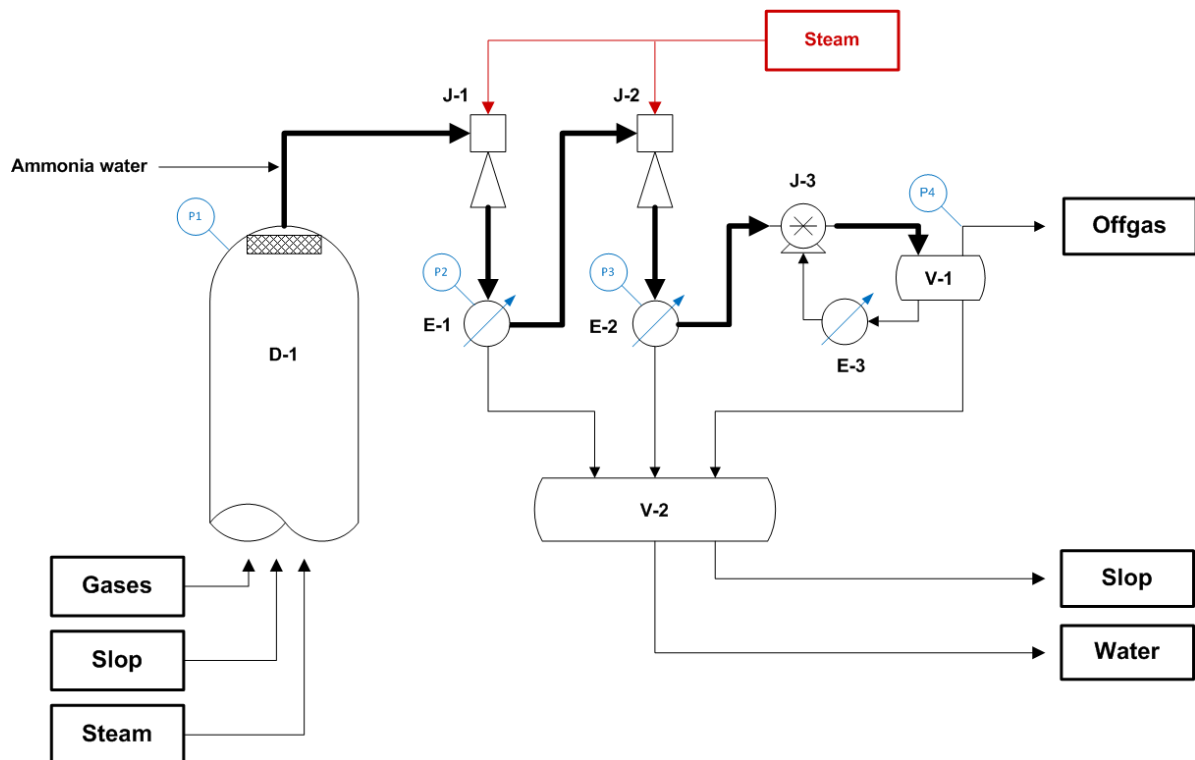
**Figure 2: Vacuum system pressures survey**

Suction and discharge pressures at 2<sup>nd</sup> and 3<sup>rd</sup> stages did not change after the revamp. This means:

- The 2<sup>nd</sup> and 3<sup>rd</sup> stages are working well as they did before the revamp (no wear).
- The 2<sup>nd</sup> and 3<sup>rd</sup> stages gas load is the same as before the revamp. This observation and offgas analysis for oxygen content excluded massive air leakage from the list.

At the 1<sup>st</sup> stage, the suction pressure was much higher after the revamp. This signifies possibility of either 1<sup>st</sup> stage ejector wear or column overhead line blockage.

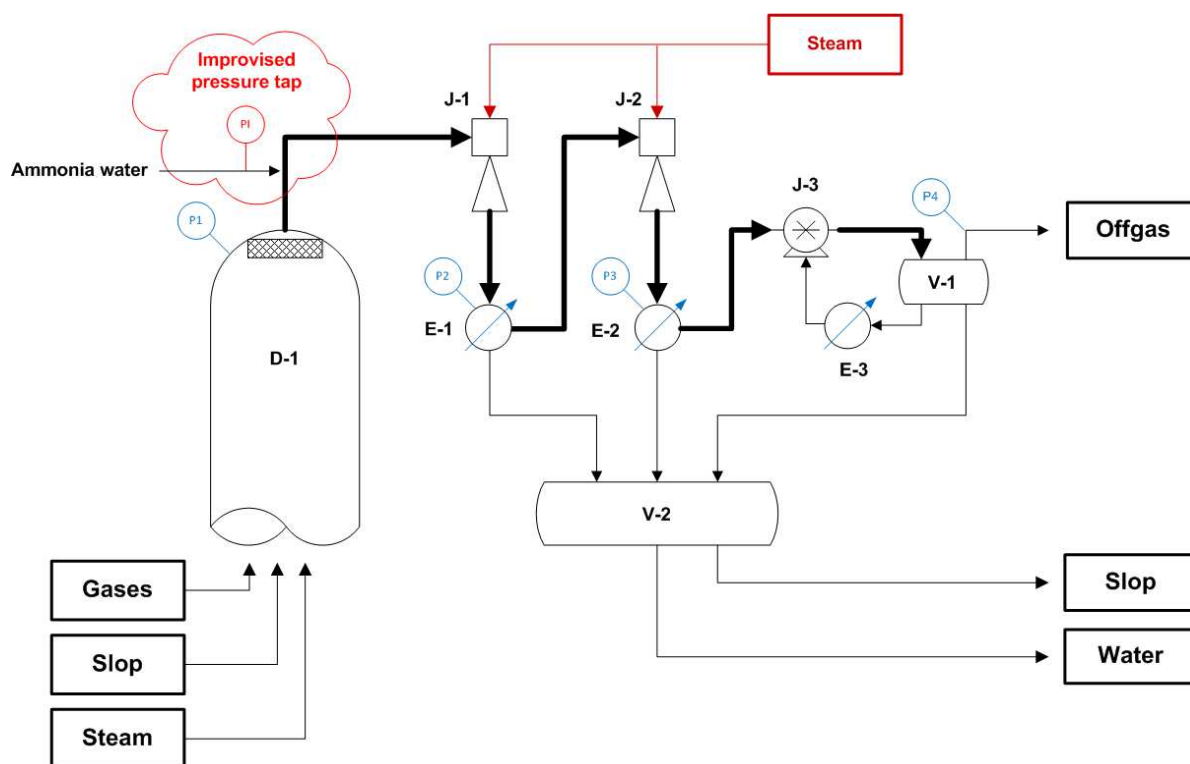
**Figure 3: Vacuum system pressures survey**

Now it is crucial to pinpoint the exact location where column top pressure was measured. Pressure tap was not located at 1<sup>st</sup> stage jet suction but at top of the vacuum tower, below the demister pad. As there was no pressure tap, a digital manometer was installed temporarily at the ammonia water injection point while ammonia water injection was temporarily interrupted.

**Conclusion: High column pressure was caused by plugged demister.**

The most likely cause was ammonium salts deposition in the demister pad.

Ammonia water injection point design was poor – instead of spray nozzle there was just a simple 1” line connected to the vertical part of vacuum tower overhead line. Ammonia water then could flow downwards along the overhead pipe wall to the demister pad where ammonia would then react with hydrogen sulfide from the offgas forming salt deposits.

Since ammonium bisulfide salts decompose at elevated temperature, GTI Solutions recommended Client to increase column top temperature and to add more stripping steam. Following the proposed actions, the tower pressure stopped rising and some time later it dropped down to 4 kPa abs.

Column internals inspection during the turnaround confirmed ammonia salts deposits in the demister pad. To prevent similar problems in future, the demister pad was removed and ammonia water injection point was redesigned.

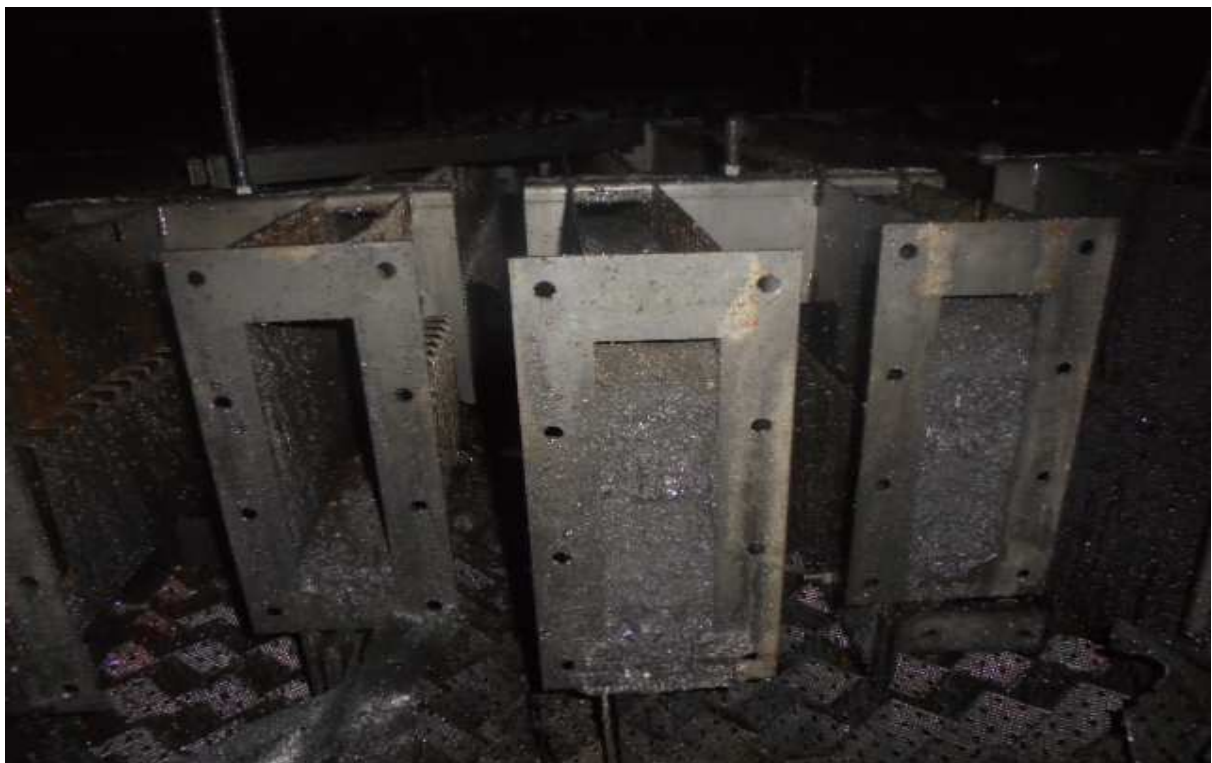
**Figure 5: Plugged trough distributor**

Pumparound distributors are generally at risk of particulate fouling and this is one of the reasons that spray nozzles are the preferred type of distributor. The hydrocarbons in these systems are recycled through a heat exchanger bank effectively for several years. This means that corrosion particles, coke particles, and any other solid materials could pass through the trough diffusers. Even strainers typically installed outside the tower may not be sufficient to stop all particles from entering the tower. In addition, long residence time in the gravity/trough distributors not seen in pressure/spray nozzle distributors at high operating temperatures can result in coke formation inside the troughs. Figure 5 shows exactly what can happen.

In addition to reducing the packed bed performance, the plugged distributor can lead to additional problems that included the fouling and plugging of the packing. A dry area of packing that no longer gets liquid will run hot, which will encourage coke formation of droplets. This typically start out small and then will grow rapidly over time as coke itself is an excellent nucleation site for more coke formation. Eventually the packed bed will become plugged causing higher pressure drop due to reduction in void area and thus poor fractionation or heat transfer performance.

For this particular case, the hole size was increased from 5~6mm up to 7~8mm and all hole elevations were increased. This was at the expense of turndown operation that was not critical since in over a decade of operation the tower had not operated at substantially reduced charge conditions.

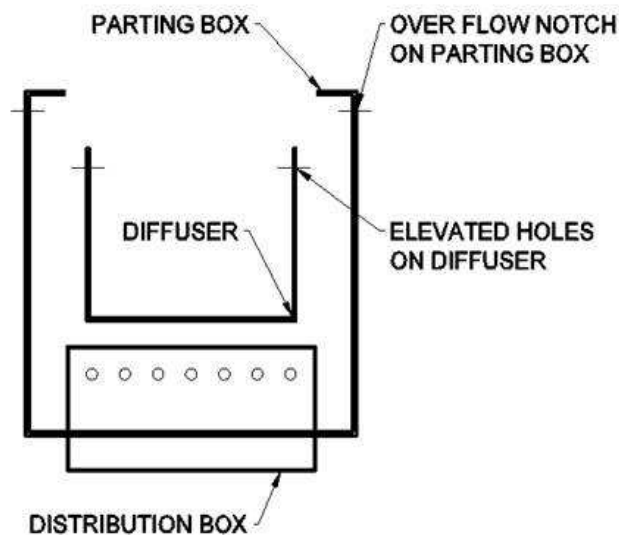
**Figure 6: Multiple stage design of trough distributor**

Increasing the hole elevation from the deck of a gravity distributor can also help increase column run length. In this case, an additional volume of solid material will be collected below the hole elevation before onset of plugging of the holes. It should be noted that this design consideration also increased the residence time dramatically as liquid leaves the area below the elevated holes only by drain holes, typically few in quantity and also small in size.
