## **69d Revamping a Demethanizer for Improved Separation and Energy Performance: Lessons Learned from Two Internal Retrofits**

*Ian Buttridge, Vice President of Technology  
David Lin, Head of Global Sales & Marketing  
GTI Solutions*

*Luis Alberto Torres-Morales, Process Engineer  
Jorge Luis Cabrera-Amador, Process Engineering Manager  
Leandro Ruiz-Ruiz, Process Engineering Superintendent  
Braskem Idesa*

Prepared for 38th Ethylene Producers Conference – Operations Session  
AIChE 2026 Spring Meeting

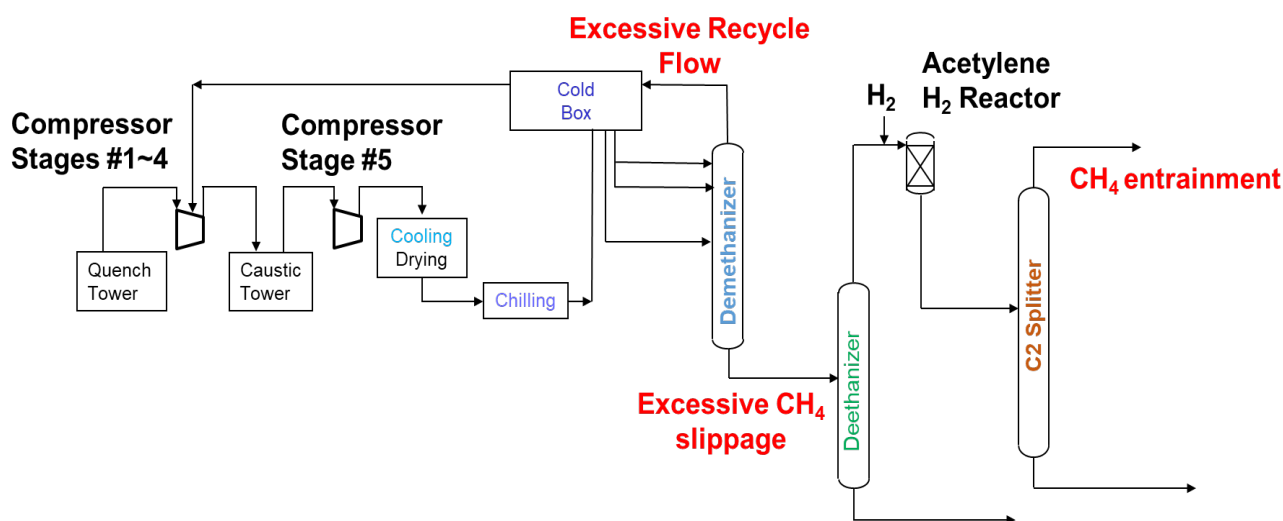
Figure 1. Operation results

The column separates methane and lighter components as overhead products and C<sub>2</sub>+ hydrocarbons as the bottom product. The design top recycle rate was 32 t/h, and the methane specification in the bottom product was 200 ppm. Since start-up of the ethylene plant, the demethanizer column has exhibited flooding at approximately 95% of its original design capacity, preventing stable operation at the full design rate of 125 t/h ethylene production. The key operating issues are illustrated in Figure 1. To mitigate these limitations, cracker furnace severity was increased in an effort to reduce the hydraulic load on the column. However, even under higher conversion conditions, the column continued to experience significant hydraulic constraints.

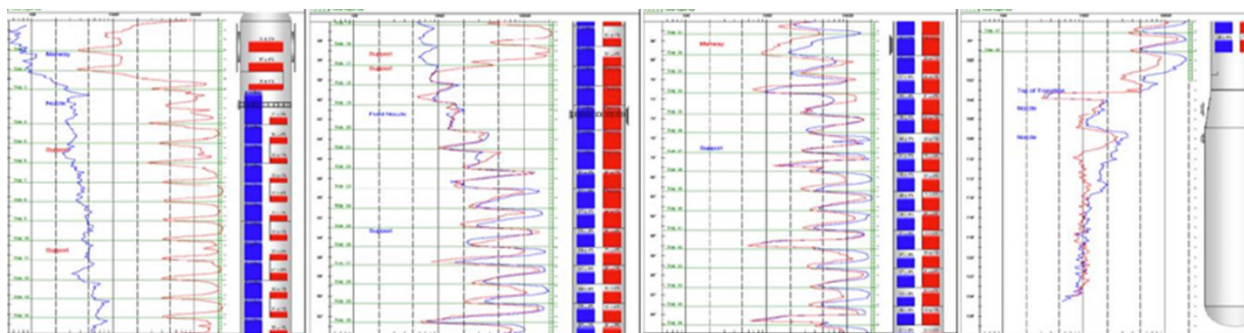
As part of the troubleshooting effort, gamma scan tests were conducted, confirming internal hydraulic issues within the tray section (Figure 2).

**Figure 2. Gamma scan results showing maldistribution in tray section**

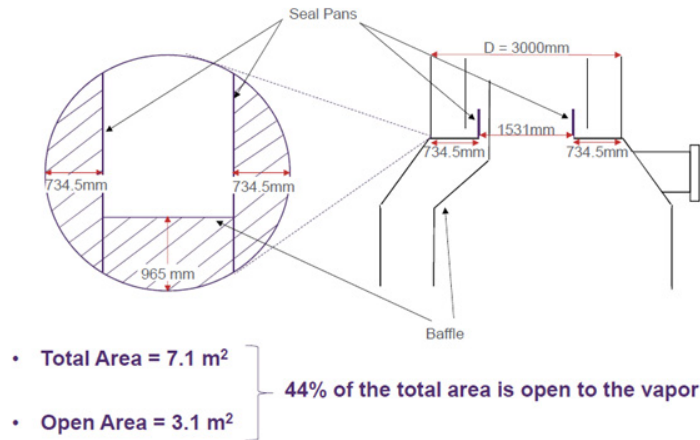
**Figure 4: Bottoms Reboiler Return Arrangement**

The licensors later concluded that the deterioration in separation performance was likely attributable to inadequate vapor distribution from the reboiler return, compounded by hydraulic obstruction associated with the seal pan and adjacent baffles. These internals were found to block more than 55% of the column cross-sectional area, thereby severely restricting vapor-liquid contact efficiency.

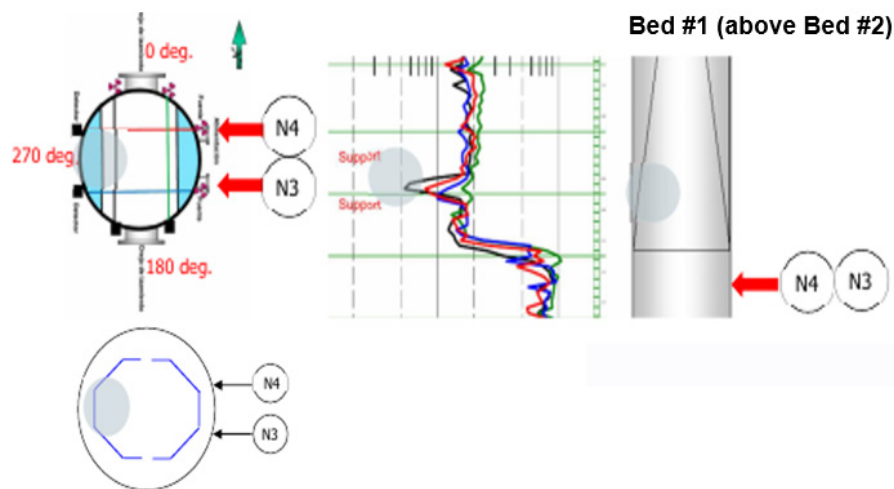
**Figure 5: Excessive Feed Momentum**

In March 2024, a joint study was initiated by Braskem Idesa and GTI Solutions to address the persistent performance deficiencies observed following the 2018 revamp. The review identified several critical issues contributing to the loss of separation efficiency. The incoming feed was found to exhibit excessive momentum as shown in Figure 5, with an estimated vapor fraction of approximately 90%, leading to poor phase distribution upon entry to the column. Gamma scan analysis further indicated liquid accumulation at the base of Packing Bed #3, likely caused by localized vapor maldistribution.

**Bed 1** - A new flashing feed gallery and liquid distributor were installed to improve phase distribution, while the existing packing was retained and reused.

**Bed 2** - Bed 2 was upgraded with a new flashing feed gallery, liquid distributor, and V-baffle diffusers to enhance vapor and liquid distribution. The existing packing was inspected and found suitable for continued service, and was therefore reused.

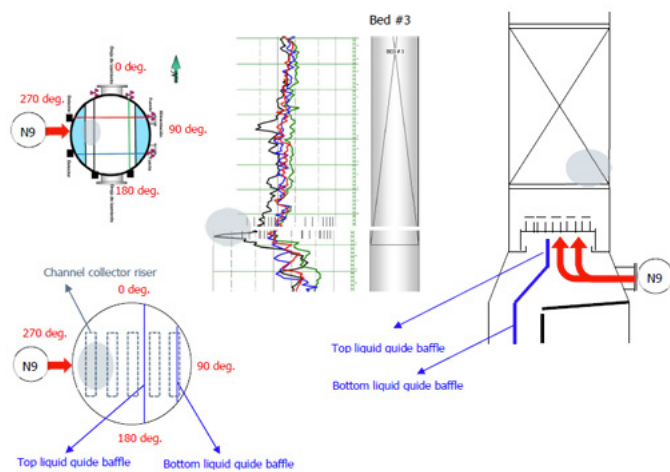
**Figure 6: Reboiler Return**

In addition, the existing channel collector was determined to provide inadequate vapor distribution across the column cross-section, further exacerbating maldistribution effects.

The column bottom internals were upgraded through installation of a DCT-210 riser collector, replacing the existing channel collector. In addition, the upper liquid guide baffle was removed to eliminate unnecessary flow obstruction. The new riser collector employs cylindrical risers equipped with restriction plates at their base, promoting uniform vapor distribution across the full column cross-section and improving overall vapor-liquid contact efficiency.

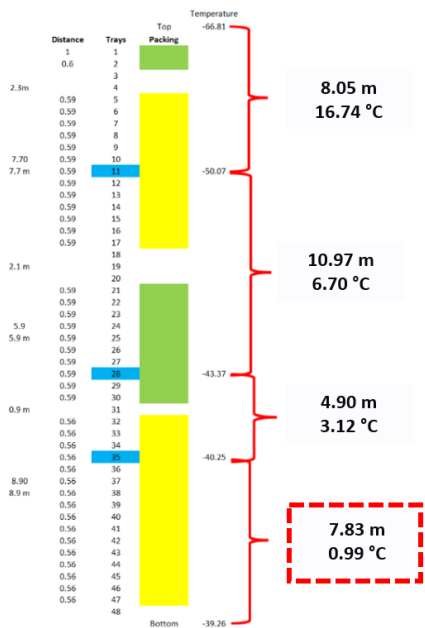
**Figure 7: Column Temperature Profile after first revamp**

The height of Packing Bed #3, at 8.9 m, was also identified as a contributing factor; such an unusually tall bed remains inherently susceptible to liquid maldistribution. Additional evidence of poor fractionation was obtained from the column temperature profile. Although gamma scan interpretation in packed beds can be challenging due to the large volume of internal material, the temperature profile provides a more reliable indication of mass transfer performance. In this case, the very low temperature gradient across the bottom bed, less than 1°C (Figure 7); clearly indicated a lack of effective fractionation in this section.

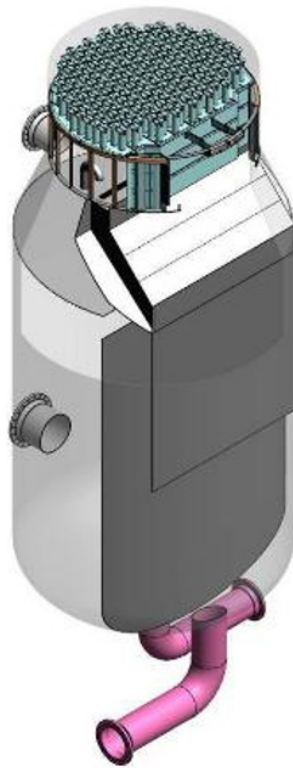
**Figure 12: Bottom Arrangement**

Inspection during the turnaround confirmed that inadequate vapor distribution was one of the root causes of the observed performance deficiencies. The previous collector tray directed liquid toward the seal pan and reboiler compartment, while the longitudinal baffle obstructed a substantial portion of the column cross-section. This configuration significantly restricted vapor flow and hindered uniform distribution across the column.

As part of the revamp, the existing collector and seal pans were removed and replaced with a riser-type vapor distributor. The new configuration provides markedly improved vapor distribution across the full column diameter, thereby enhancing overall mass transfer performance.

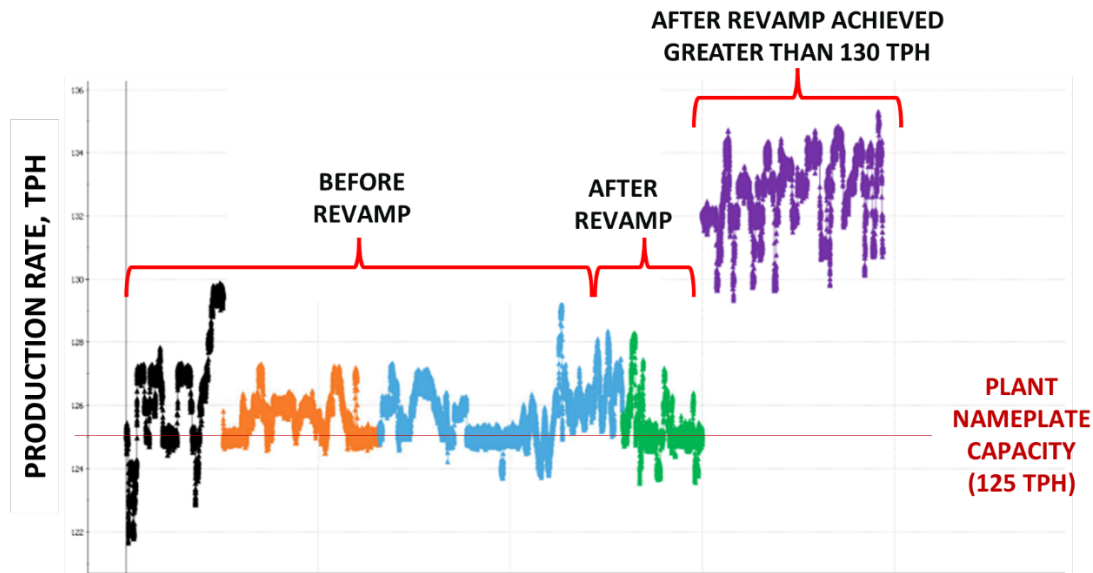
**Figure 13: Post 2<sup>nd</sup> Revamp Capacity**

Key performance indicators showed significant improvement. Top recycle flow decreased from  $\geq 85$  t/h to a range of 61–64 t/h, while methane concentration in the bottoms product was reduced from 1600~1750 ppm to around 500 ppm. These improvements provide greater operational flexibility, enabling tighter control of methane slip while minimizing recycle load to

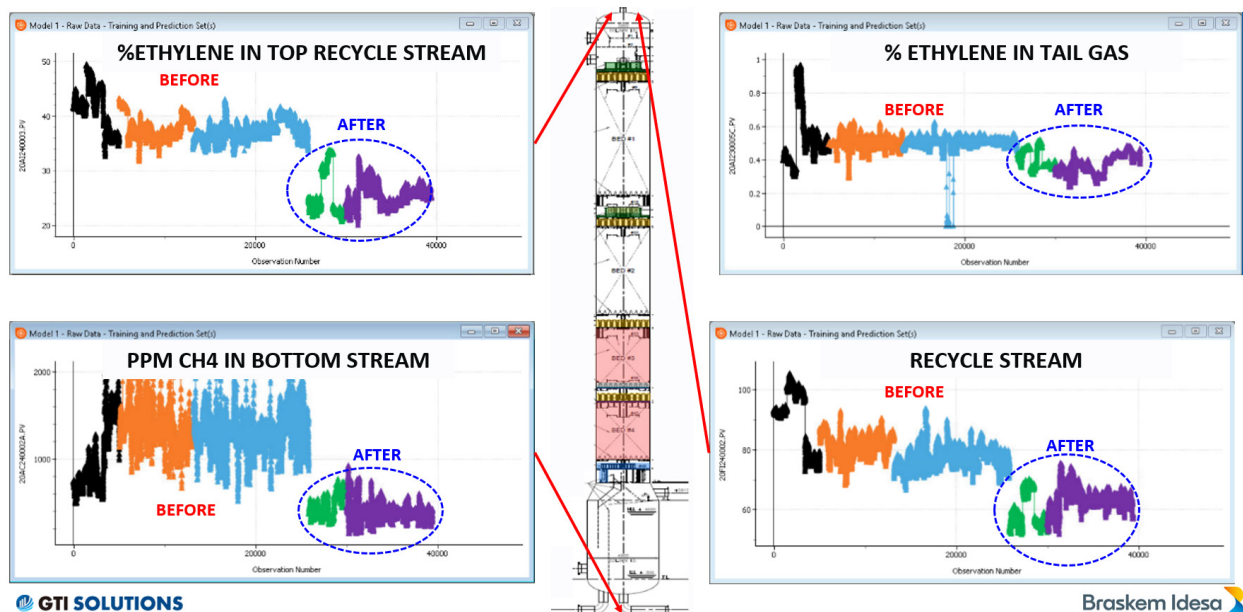
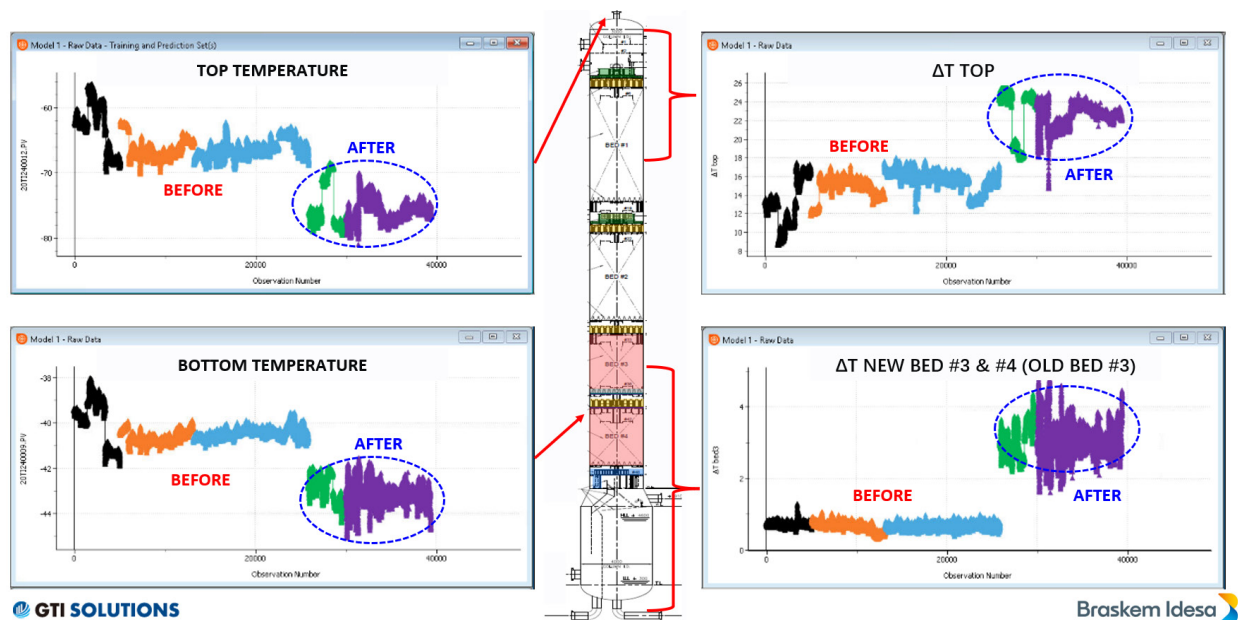
the cracked gas compressor. Column temperature profiles also demonstrated substantial enhancement in fractionation efficiency. Prior to the revamp, the temperature gradient across the bottom bed was approximately 1°C, indicating poor mass transfer. Following the modifications, the bottom bed  $\Delta T$  increased to approximately 4°C, while the top section  $\Delta T$  improved from 16°C to 23°C. In addition, the overhead temperature now consistently reaches the design value of  $-75^{\circ}\text{C}$ , confirming improved separation performance and more effective vapor–liquid contact throughout the column.

**Figure 14: Post Revamp Operating Data**

**Figure 15: Post Revamp Operating Data**
