# **TRICKY LIQUID DISTRIBUTORS**

***Petr Lenfeld***

*Prepared for Presentation  
at the  
Kister Distillation Symposium 2017  
Topical Conference  
at the  
2017 Spring Meeting and 13<sup>th</sup> Global Congress on Process Safety  
of the  
American Institute of Chemical Engineers  
San Antonio, Texas  
March 26 – 30, 2017*

### Case Study #1: Fire in Ammonia Absorber Column

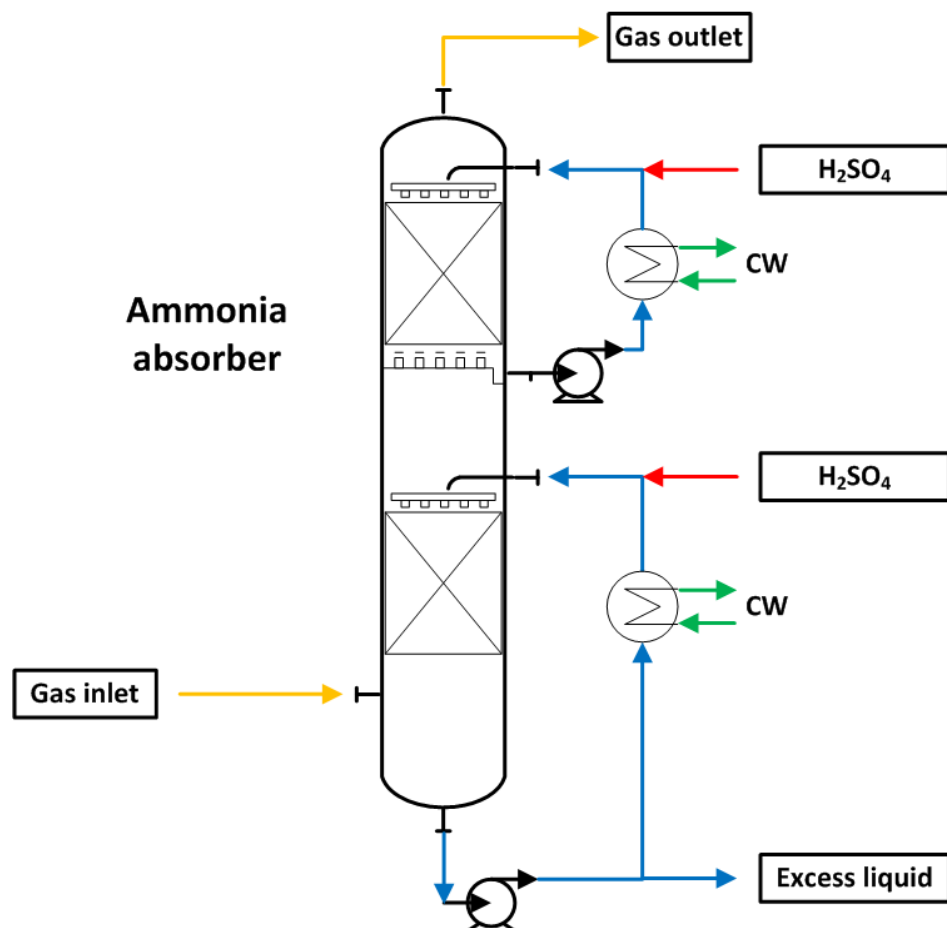
Figure 1: Ammonia absorber

To make matters even worse, after removal of damaged packing, it was found that the column shell was deformed in the bottom section. When thermal insulation was removed it was clear that the damage was caused by internal fire in the bottom structured packing bed, a consequence of pyrophoric compounds self-ignition during the shutdown operations.

- Plugged distributor, leading to lower bottom section efficiency.
- Operators' wrong interpretation of column performance and subsequently overdosing of sulfuric acid.
- Packing damaged by high acid concentration.
- By "design", distributor was not properly secured. As a cost saving protocol, the vendor by default omitted the packing hold-down grid in the design. The liquid distributor was simply supported by the structured packing underneath it. For this particular case, liquid distribution quality deteriorated once the distributor shifted/tilted due to dissolved packing underneath it. Out of level liquid distributor led to localized dry spots across the packed bed causing further deterioration in column performance.
- Pyrophoric compounds accumulated in dry packing bed.
- Fire during shutdown.

- Column shell was repaired in the vessel manufacturer’s shop.
- New tower internals were provided on an emergency basis. Channel type distributor was replaced with a proven ladder type.
- Pressure transmitter was installed at distributor inlet piping as an indicator of distributor plugging.
- No filter was installed based on previous successful experience with ladder type distributor.

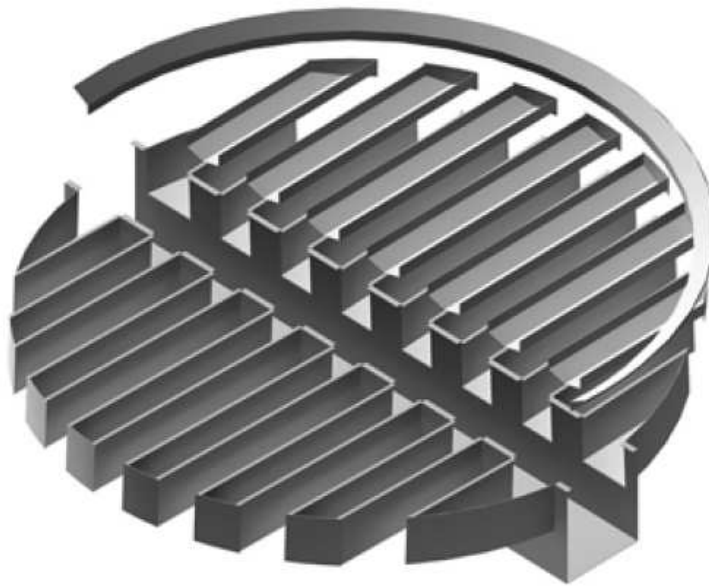
**Figure 2: Typical channel through type distributor**

Problem started shortly after the shutdown for cleaning. During the shutdown, pumparound coolers were cleaned; column packing and distributors were washed but piping was not washed nor flushed. It was postulated that liquid distributor was plugged by scale deposits released from piping and column shell walls after unit startup.

Rust and scale deposits formation is commonly seen and reported in column operations. This specific problem and design criteria were discussed with the tower internals vendor before the revamp took place. For unknown reasons, a distributor prone to plugging was selected but no preventive measures were applied (no filter requested). The design approach made plugging problem practically inevitable.

Previously, operators had never encountered distributor plugging because of different distributor type: ladder distributor did not suffer from plugging as its open construction allowed the packing underneath to be wetted or washed. The replacement with a “new and better” channel type distributor, though may be an optimum choice from process point of view but ignoring possible plugging, resulted in a serious problem.

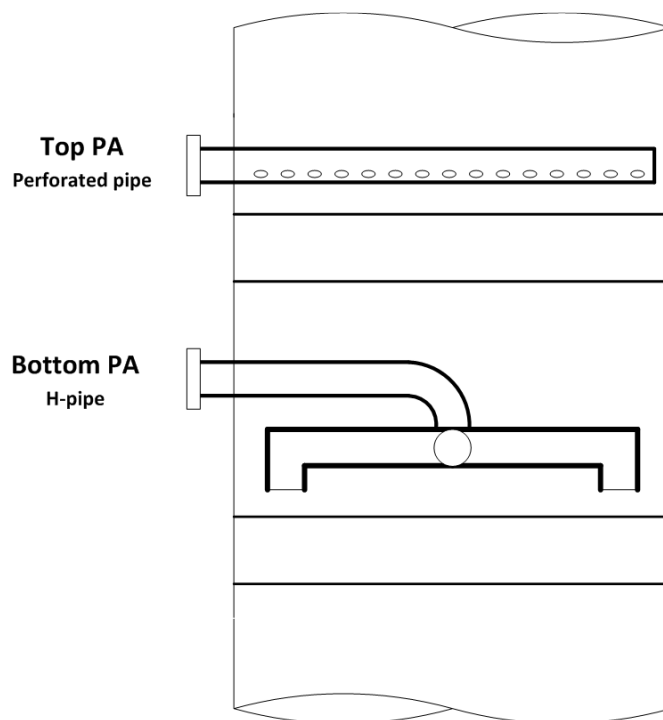
**Figure 5: Pumparound inlet pipes before modification**

Hydraulic shocks were most audible in column pumparound section thus a pumparound return distributor was suspected as a possible root cause. Tower internals supplier strictly rejected this hypothesis, and refused to visit the plant site claiming that “this behavior is not possible”. Based on vendor statement, other potential causes were investigated:

Hydraulic shocks are usually induced by unsteady two phase flow, either by liquid flashing or vapor condensation. Based on field observations, high P/A return temperature prevented shocks while low temperature induces shocks thus liquid flashing at P/A return nozzle was excluded from the list. No matter how strange it sounded, the real cause of the problem is an instant vapor condensation on cold liquid surface inside of the P/A return distributor.

- Hot vapor from column enters the distributor pipe and condenses on cold liquid surface.
- Instant vapor condensation created local vacuum (draft) inside the P/A return pipe, causing more vapor to be sucked into the pipe.
- High velocity vapor flow reversed the liquid flow direction, forming a slug inside of the pipe.
- The resultant slug flowed in the opposite direction against the main liquid stream. Hydraulic shock resulted when the slug struck the main liquid stream.
- Once the liquid exited the pipe the vicious cycle repeated itself.

Column internals modifications were performed during a short shutdown. Both top and bottom pumparound return distributors were equipped with hydraulic seals to prevent vapor backflow.
