# **TROUBLESHOOTING AND OPTIMIZING REFINING VACUUM TOWERS**

*Prepared for Presentation  
at the  
Kister Distillation Symposium 2019  
Topical Conference  
at the  
2019 Spring Meeting and 15<sup>th</sup> Global Congress on Process Safety  
of the  
American Institute of Chemical Engineers  
New Orleans, Louisiana  
March 31 – April 4, 2019*

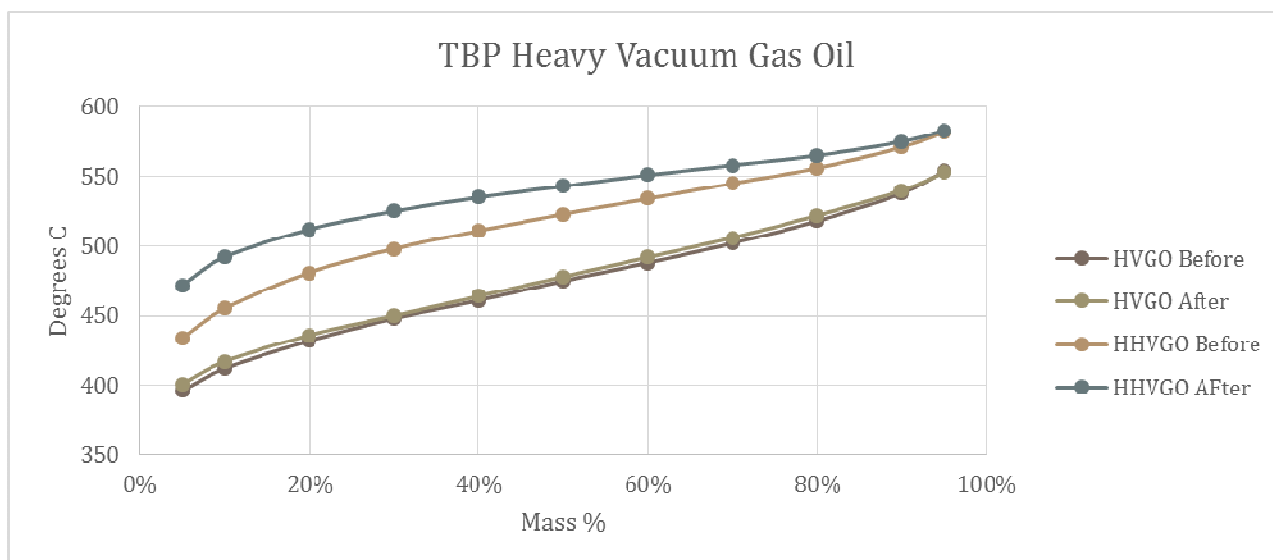
**Figure 7: Key product distillation overlaps, before and after revamp**

Immediately after revamp, which included replacement of packing, a substantial improvement in fractionation efficiency was observed in distillation overlaps.

| Distillation Overlaps | Before revamp | After revamp | Improvement |
|---|---|---|---|
| HVGO 5% - LVGO 95% | -81°C | -68°C | <b>13°C</b> |
| HHVGO 5% - HVGO 95% | -120°C | -81°C | <b>39°C</b> |
