## **69d Revamping a Demethanizer for Improved Separation and Energy Performance: Lessons Learned from Two Internal Retrofits**

*Ian Buttridge, Vice President of Technology  
David Lin, Head of Global Sales & Marketing  
GTI Solutions*

*Luis Alberto Torres-Morales, Process Engineer  
Jorge Luis Cabrera-Amador, Process Engineering Manager  
Leandro Ruiz-Ruiz, Process Engineering Superintendent  
Braskem Idesa*

Prepared for 38th Ethylene Producers Conference – Operations Session  
AIChE 2026 Spring Meeting

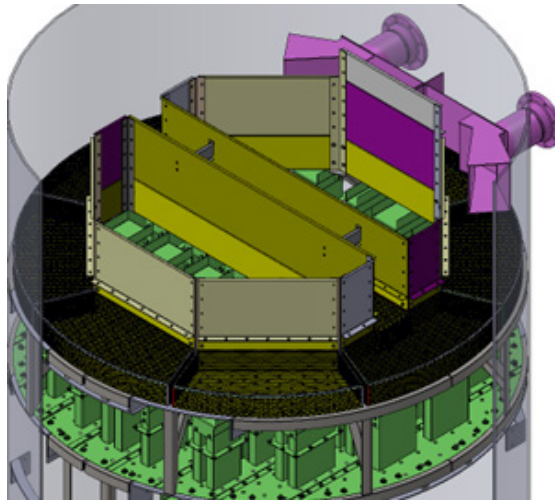
**Figure 8: New Flashing Feed Gallery Arrangement**

**Bed 2** - Bed 2 was upgraded with a new flashing feed gallery, liquid distributor, and V-baffle diffusers to enhance vapor and liquid distribution. The existing packing was inspected and found suitable for continued service, and was therefore reused.

**Bed 1** - A new flashing feed gallery and liquid distributor were installed to improve phase distribution, while the existing packing was retained and reused.

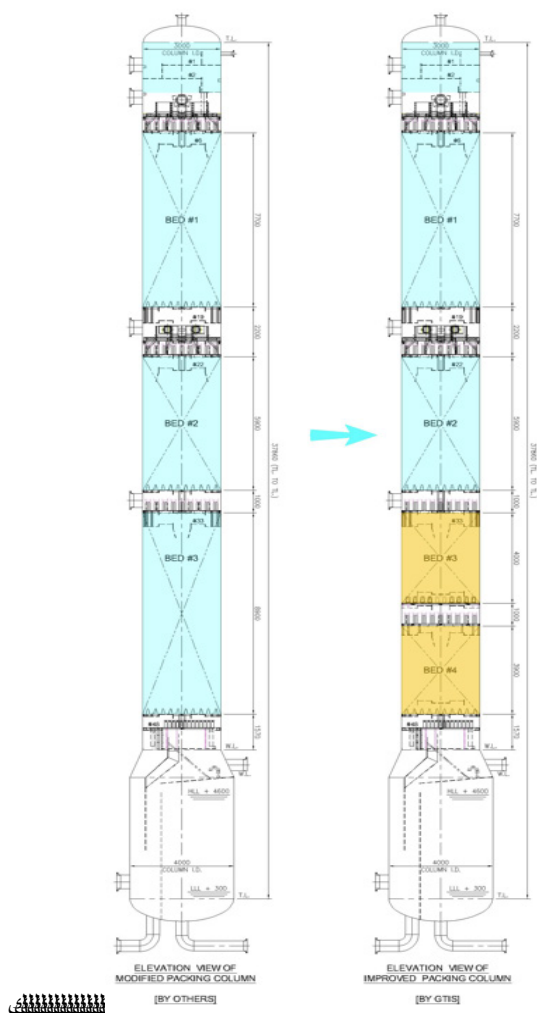
**Figure 10. Column Configuration Change**

Inspection during the turnaround confirmed that inadequate vapor distribution was one of the root causes of the observed performance deficiencies. The previous collector tray directed liquid toward the seal pan and reboiler compartment, while the longitudinal baffle obstructed a substantial portion of the column cross-section. This configuration significantly restricted vapor flow and hindered uniform distribution across the column.

As part of the revamp, the existing collector and seal pans were removed and replaced with a riser-type vapor distributor. The new configuration provides markedly improved vapor distribution across the full column diameter, thereby enhancing overall mass transfer performance.
